Cooling Towers

Data and Observations of the Effects of the Vulcan Electronic Descaler on Cooling Towers

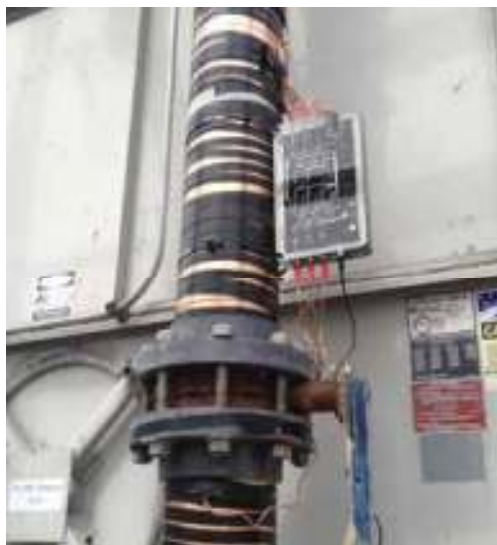
Vulcan S100 installed on cooling towers

Please find below the installation photos of the Vulcan S100 installed on the main line connected to 3 cooling towers.

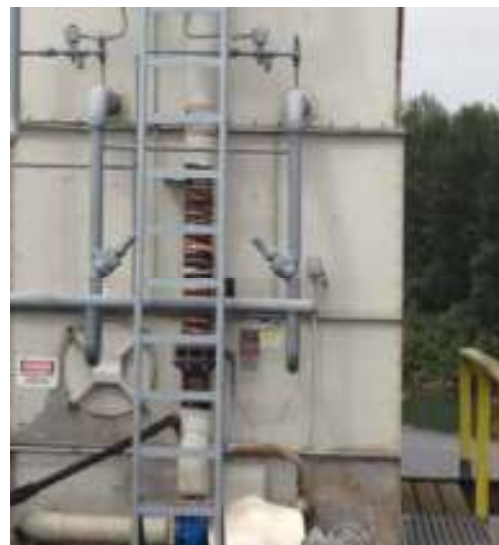
Vulcan S100 installed outside

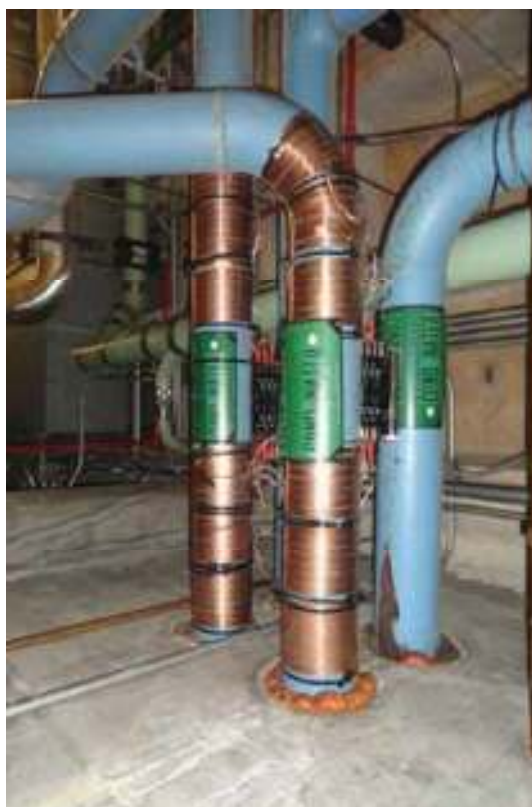
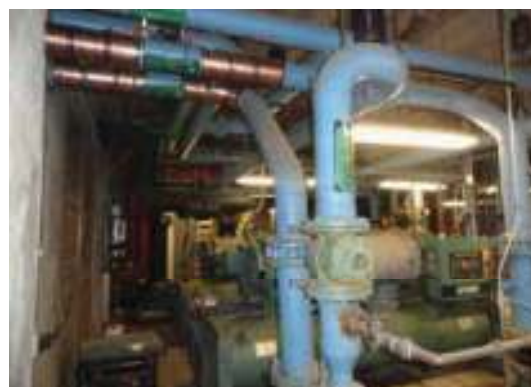
Vulcan S100 units installed on the double chiller

These pictures show 2 x Vulcan S100 units protecting the double chiller and pumps in the FAMU/FSU College of Engineering.

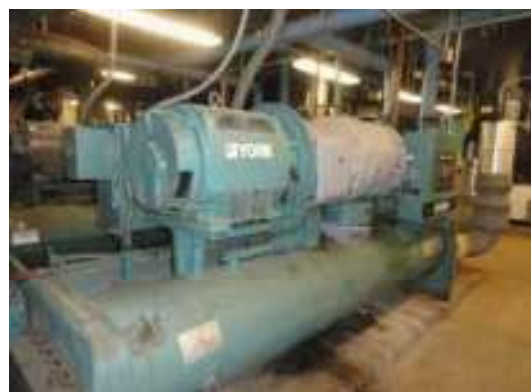
Vulcan units protecting chiller pumps from scale and rust

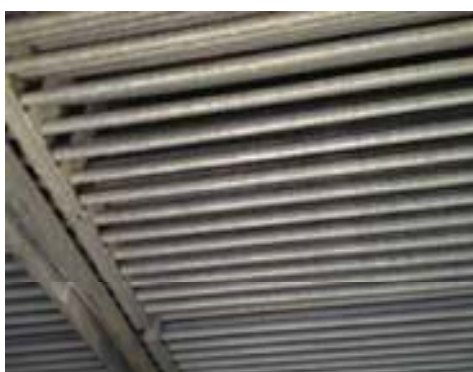
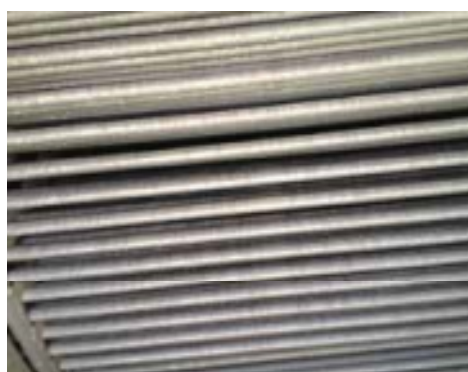
This picture was taken after 4 months the installation of the Vulcan S25. The tower was dirty/not cleaned before the Vulcan was installed.

Clean cooling tower after using Vulcan

Since the Vulcan installation, the cooling towers have been scale free and there has been no need for any chemical treatment.

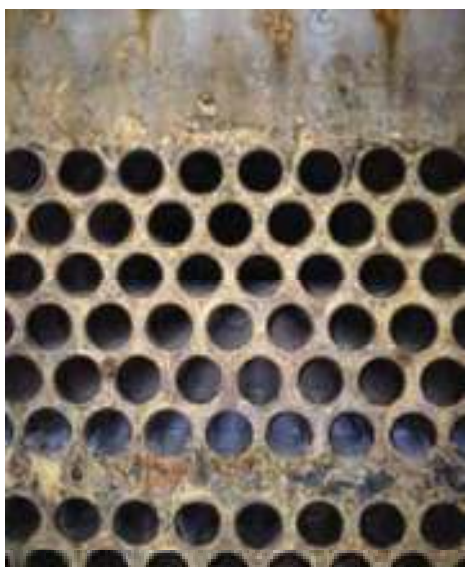
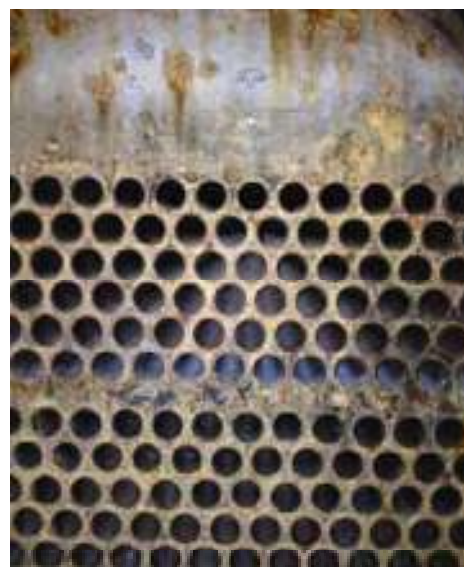
Here are two pictures from a Chiller opened for a routine cleaning, but nothing to clean after two years with Vulcan treatment.

No scale formation after using Vulcan

This Chiller is connected to a Cooling Tower which is exposed to lots of air borne contamination from surrounding farms.

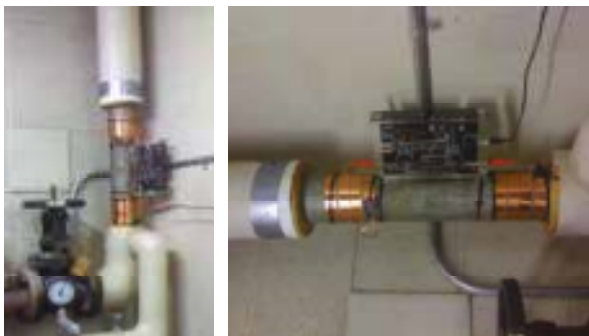
Installation of Vulcan Descaler for the entire building's water supply in the Roosevelt school

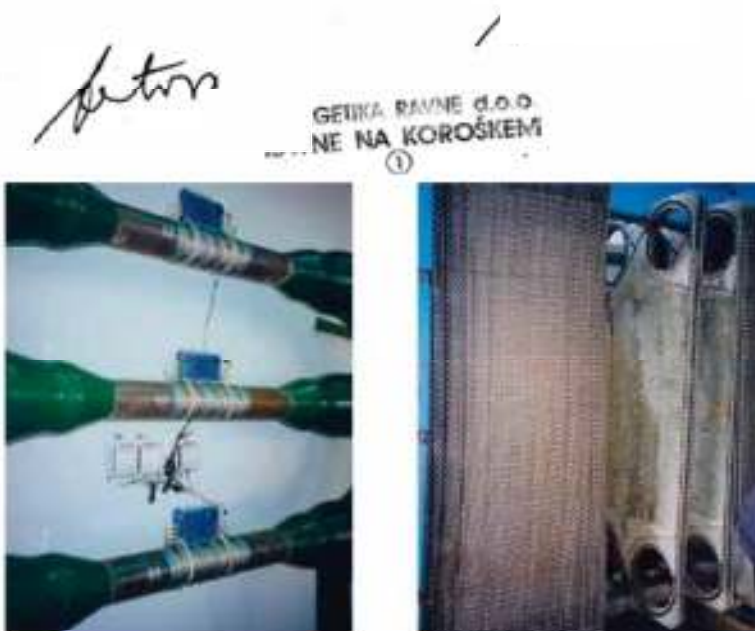
After Vulcan installation

Control of honey comb fill of
cooling tower

The inspected tubes were clean; there were no signs of lime scale accumulation.

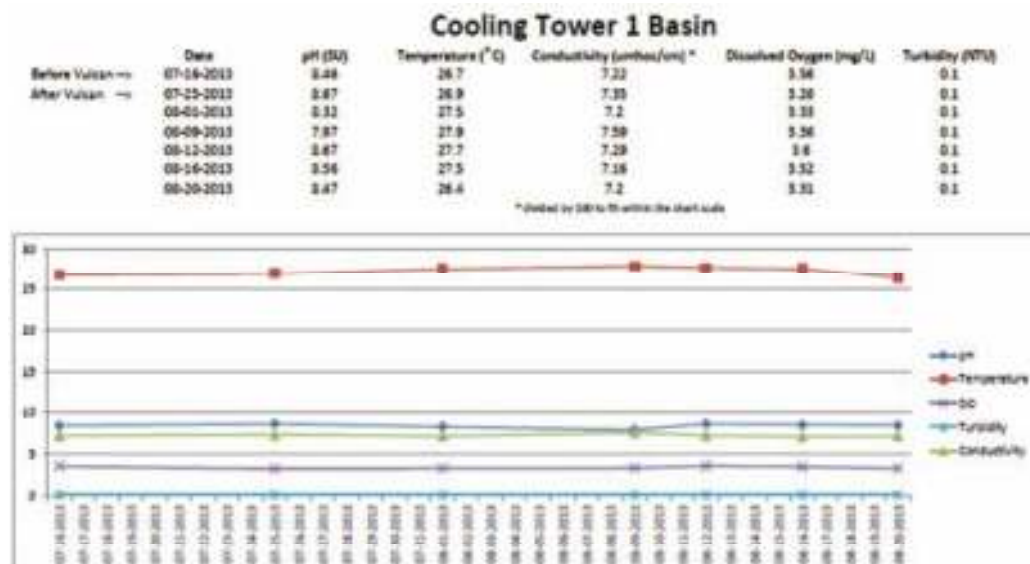
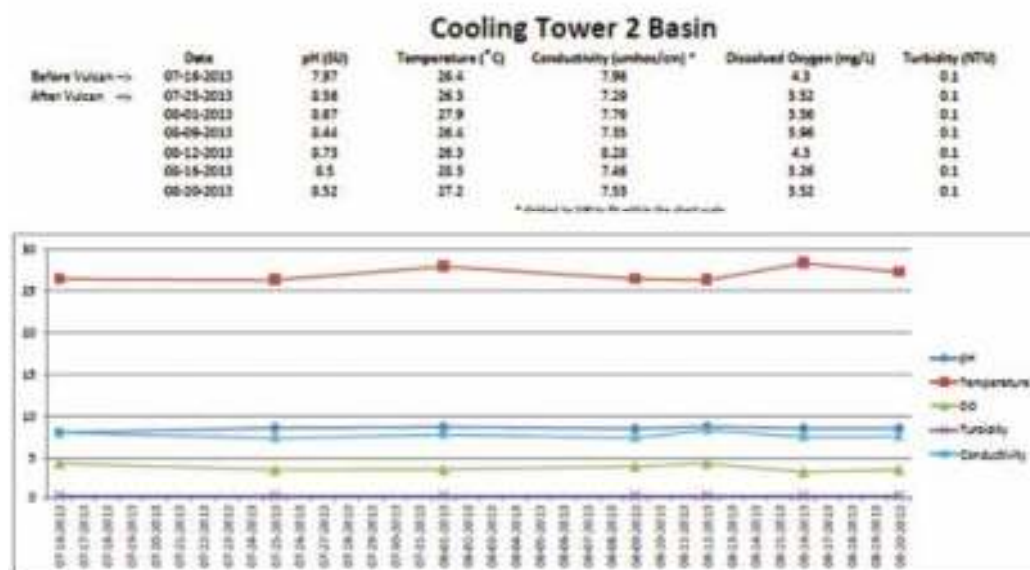
The Vulcan does not change the water quality beyond its affect on its propensity to cause scale buildup. As illustrated below, the pH, conductivity, dissolved oxygen level, and turbidity remained relatively constant during observation from before the installation to over a month after. Temperature is included, because of its affect on the other measurements and seems to correlate with the slight fluctuations observed.

We are very optimistic about continued improvement with this application. In addition to these observations, water quality measurements were also obtained from each cooling tower and are summarized in the following charts.

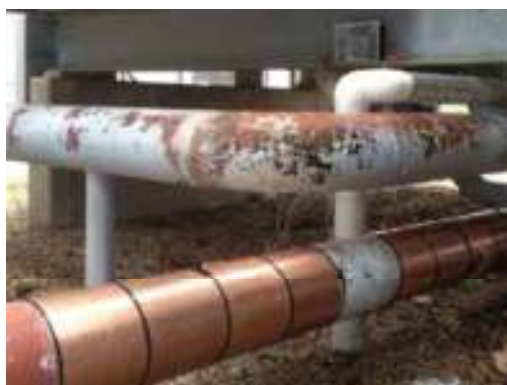
Vulcan S250 installed on a 10 inch diameter line that feeds twin cooling towers (CT-1 and CT-2)

The unit was installed on the 10 inch diameter line that feeds twin cooling towers (CT-1 and CT-2) at the FAMU/FSU College of Engineering.

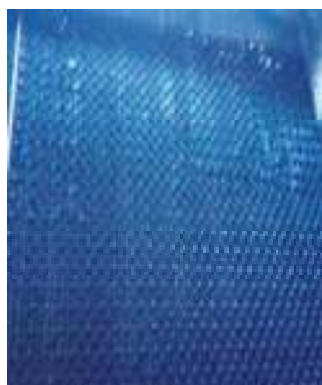
This photo was taken of the inside of CT-1.

It illustrates clean flutes that are in constant contact with Vulcan-treated water and a few dry (untreated) areas that still have some remaining green biofilm.

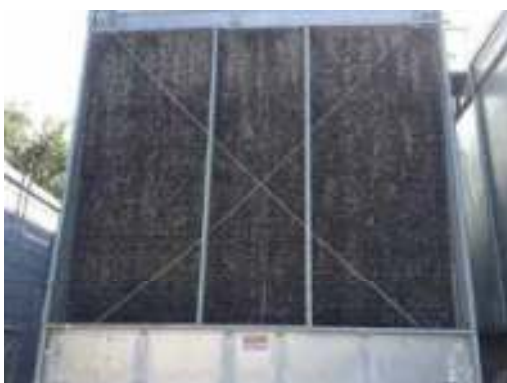
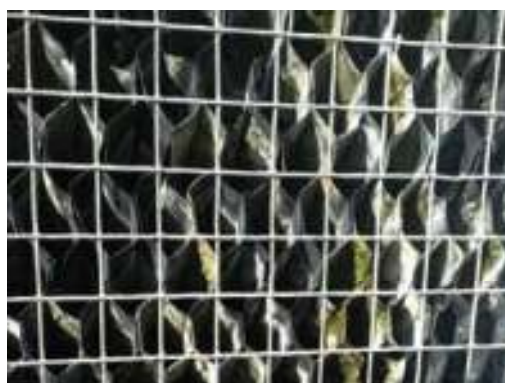
The photographs above were taken of CT-1 about 3 weeks after the Vulcan was installed.

Between the time of the installation on July 16th and examination on August 1st, the green biofilm had begun to recede and gradually disappear. The next visit was about 3 weeks after the installation, on August 9th. At that point, the green biofilm had been further reduced and the scale deposits had begun to separate from the flutes in coin-sized flakes.

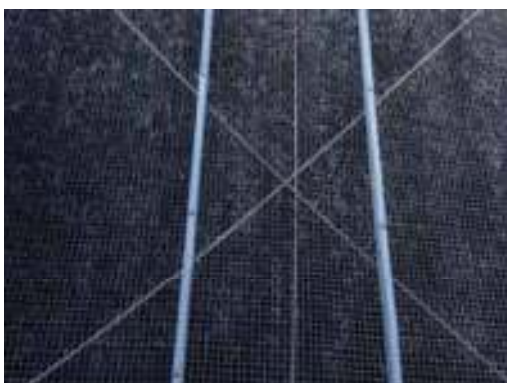
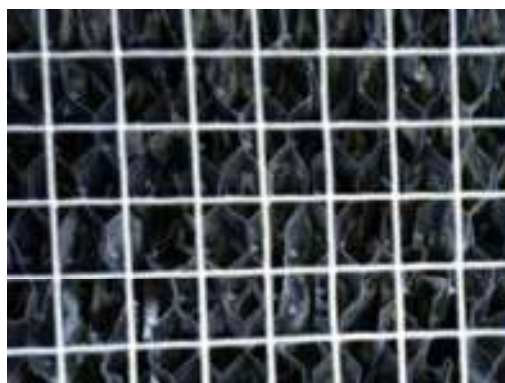
These photos were taken of CT-1 after about 6 weeks.

By August 20th, about a month after installation, the green biofilm had almost completely disappeared from the surfaces in contact with the Vulcan-treated water. The flakes of scale previously observed had fallen off in most places. The cooling tower flute surface area covered with scale deposits had been decreased by over 60%.
